PIVOT STOVES & HEATING

THERMAL TESTING OF THE PIVOT STOVES & HEATING ROOM SEAL FLUE 8 KIT IN A FLAT CEILING AND ROOF PENETRATION ACCORDING TO APPENDIX F OF AS/NZS2918:2018

Report Number: ASFT21086-PRELIMINARY REPORT
Issue date: 15 October 2021

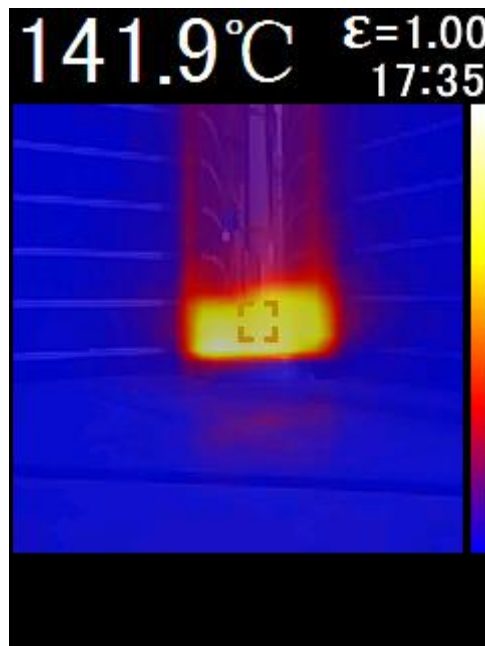
Above the ceiling

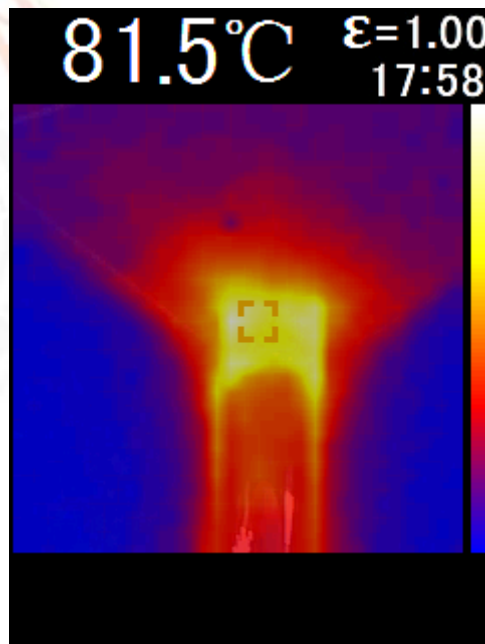
Below the roof

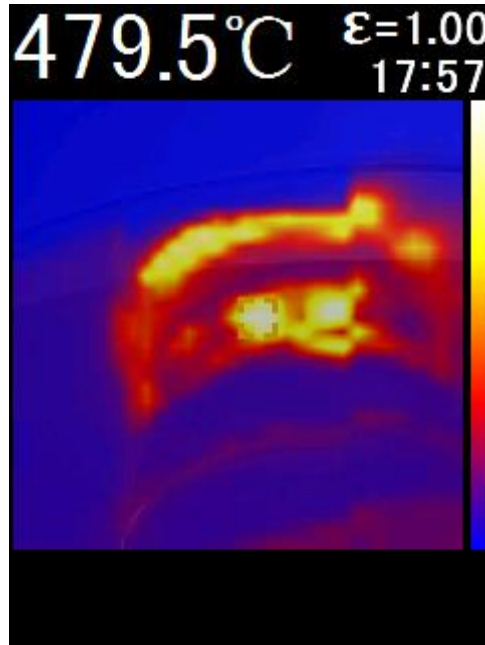
Above Roof

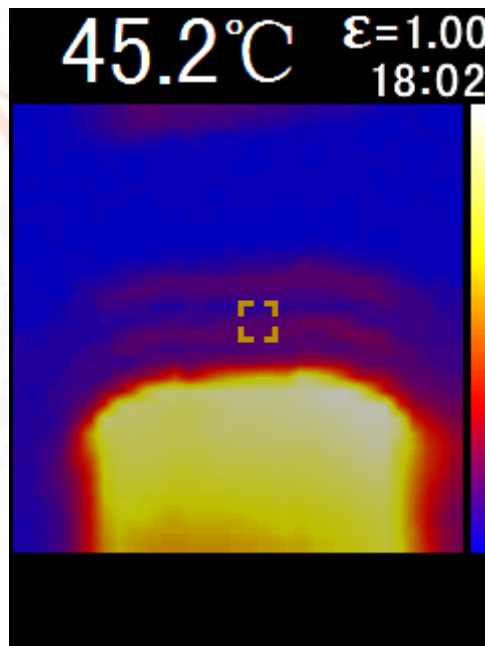
Below ceiling

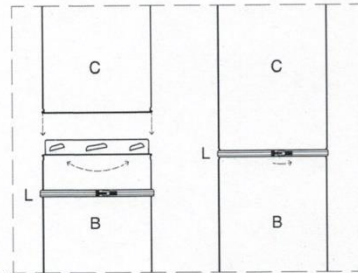
Flue Assembly

NOTE:
 To assemble flue, first lock into place, second secure locking band around joint

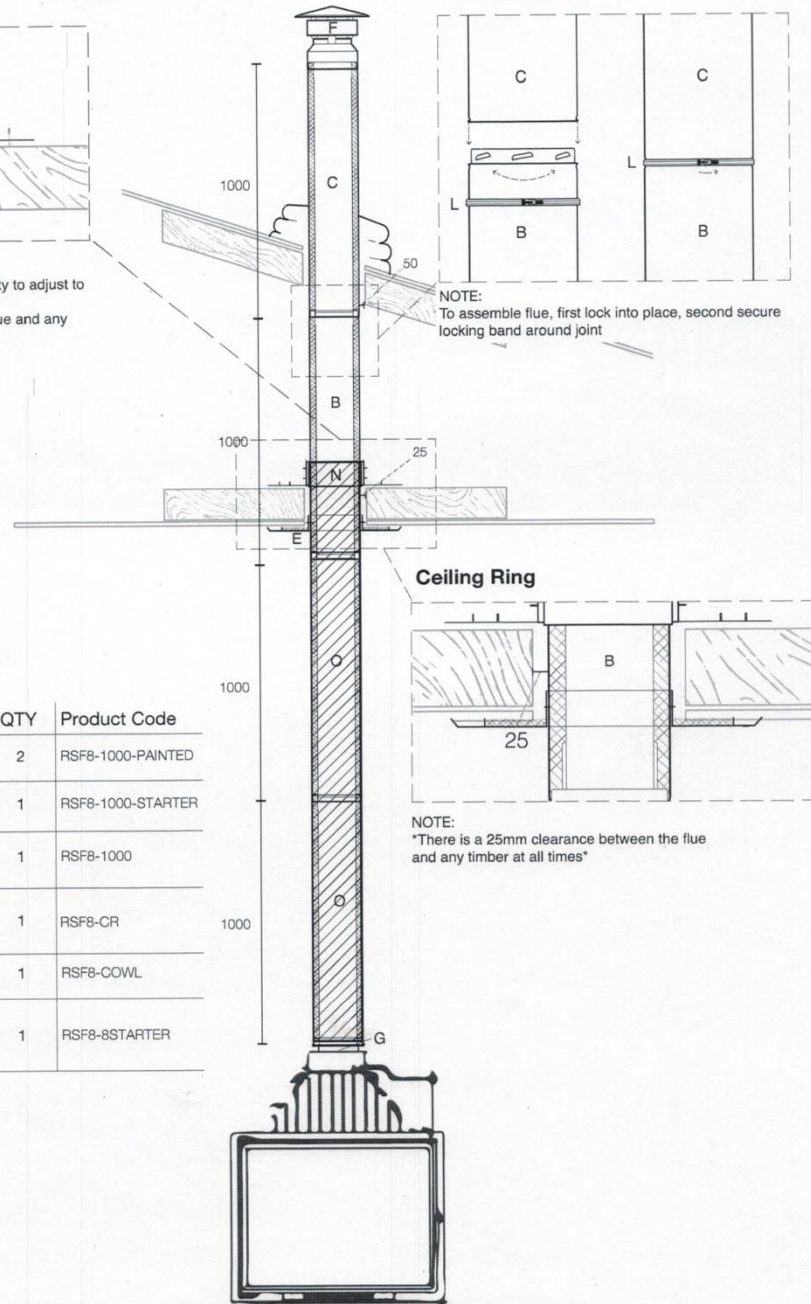
Full Room Seal Flue Kit

Item	QTY	Product Code
O	2	RSF8-1000-PAINTED
B	1	RSF8-1000-STARTER
C	1	RSF8-1000
E	1	RSF8-CR
F	1	RSF8-COWL
G	1	RSF8-8STARTER

NOTE:
 There is a 25mm clearance between the flue and any timber at all times

NOTE:
 The optional support brace (N) has the ability to adjust to any angle of adjacent roof beams
 There is a 25mm clearance between the flue and any timber at all times
