THERMAL TESTING OF THE PIVOT STOVES & HEATING ROOM SEAL FLUE 8 KIT IN A FLAT CEILING AND ROOF PENETRATION ACCORDING TO APPENDIX F OF AS/NZS2918:2018

Report Number: ASFT21086-1
Issue date: 04 August 2023

THERMAL TESTING OF THE PIVOT STOVES & HEATING ROOM SEAL FLUE 8 KIT TO AS/NZS2918:2018 APPENDIX F

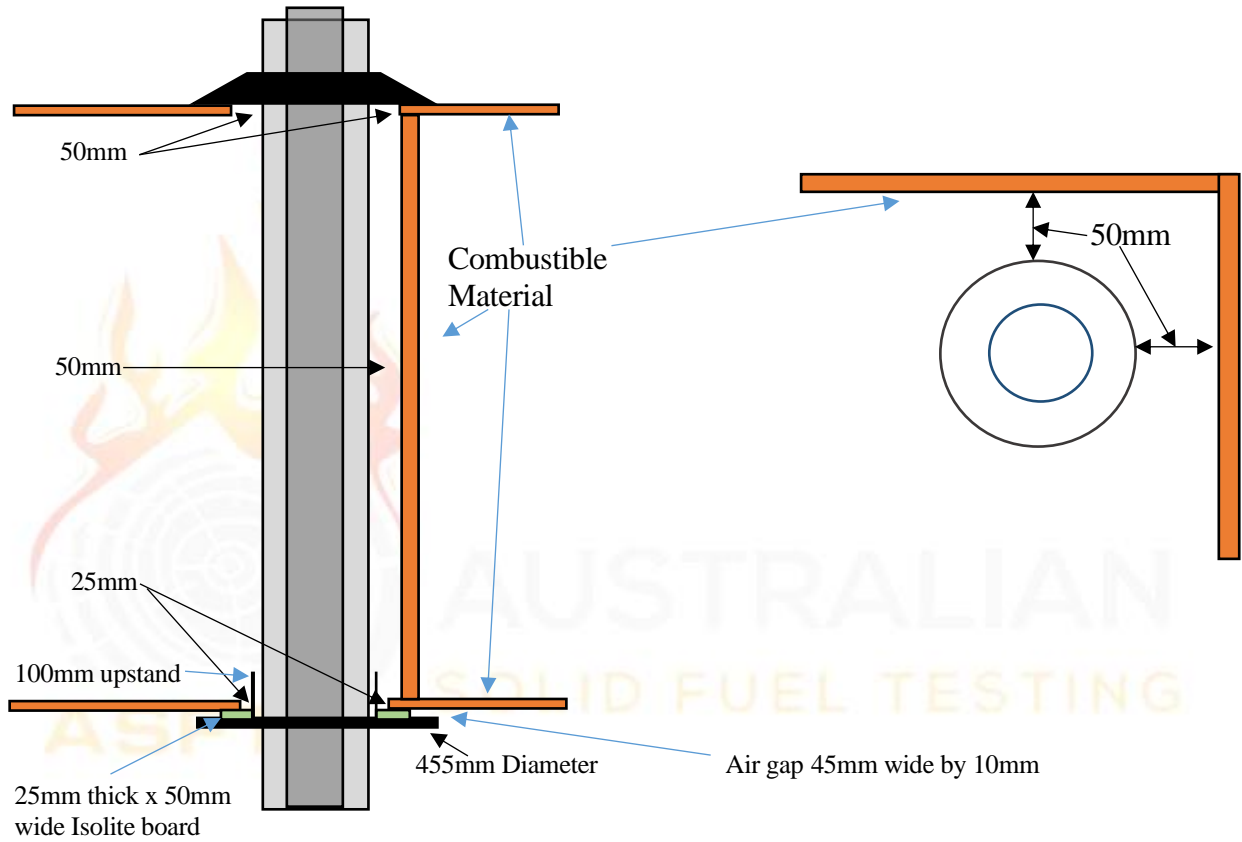
Figure 1 – Clearance Diagram

The Flue system was tested at the following clearances:
